FLIGHT SAFETY FOUNDATION

# FLIGHT SAFETY

## Protection Against Icing: A Comprehensive Overview

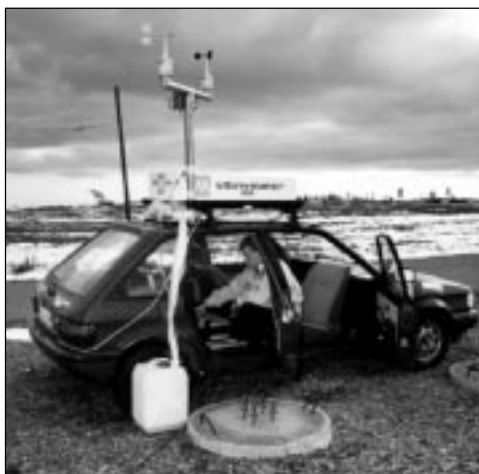
*A car is equipped with a simulated aircraft aluminum fuel tank on its roof that has a Vibro-Meter electrical ice sensor built into the tank's upper surface. Various data, including wind speed, ambient temperature, fuel temperature and other information are recorded on a computer in the car. Several Finnair first officers conduct tests to determine optimum operating characteristics and standards for the sensor.*

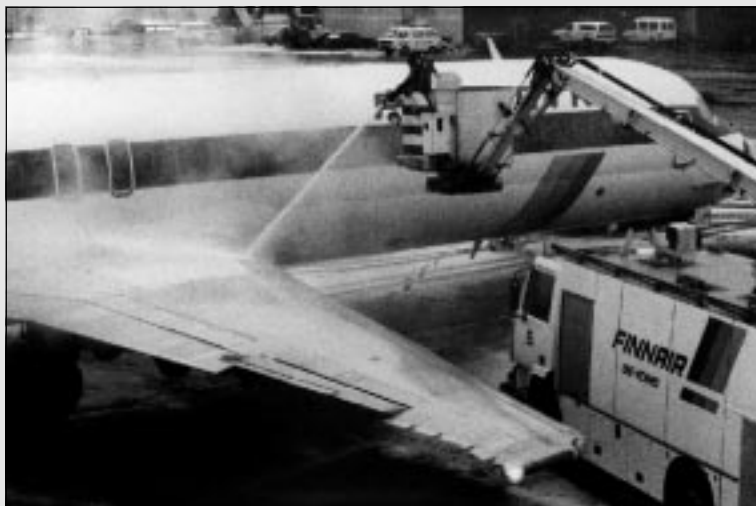
*Ice forms more readily over the wing root, where the cold fuel settles and there is more metal structure, including the landing gear components, which can contribute to colder temperatures.*

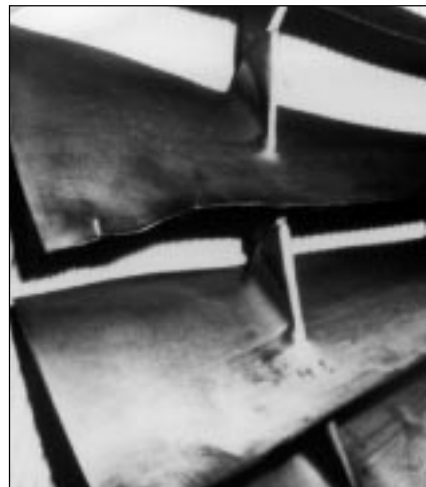
*The gentle bend in the blades is characteristic of soft foreign object damage.*

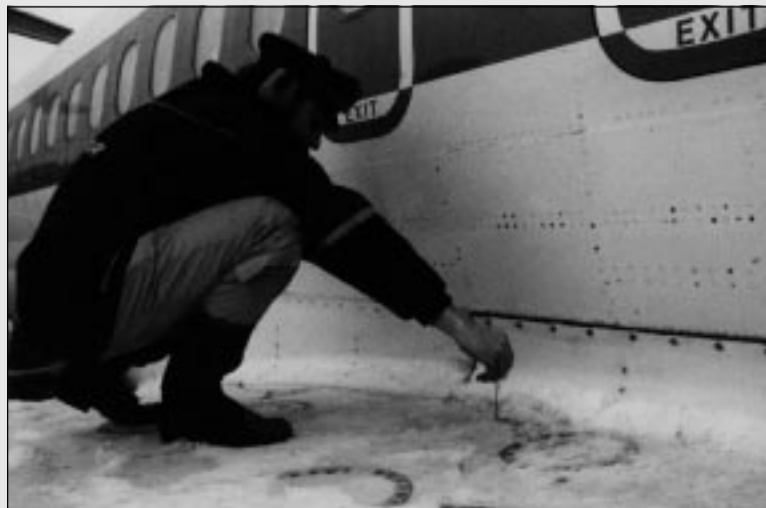
*The tuft of parachute cord moved freely, but underneath the snow, clear ice had formed, and the cord’s base was frozen solid.*

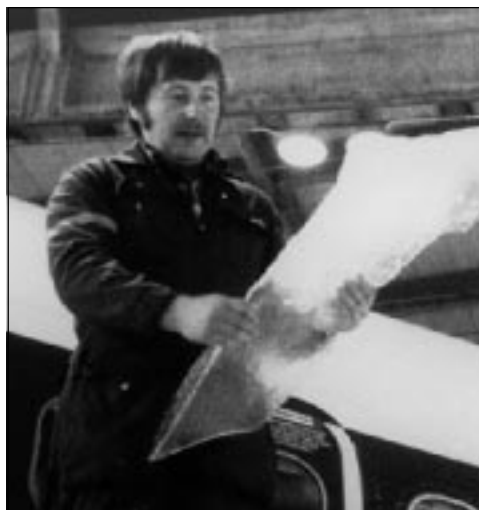
*A mechanic holds a sheet of ice taken from the wing of the Finnair DC-9 that aborted a takeoff at Helsinki-Vantaa Airport in 1985 after flexing wings on the uneven runway broke the ice free, and it was ingested into the engines.*

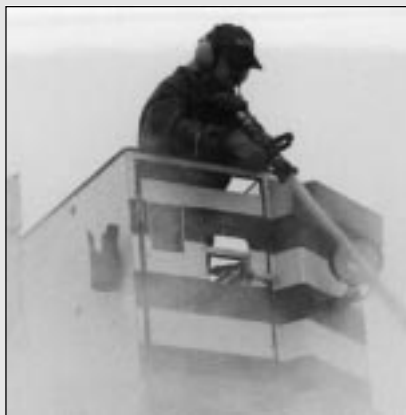
*Hot water under pressure in a tight stream was required to break ice free from an aircraft wing.*

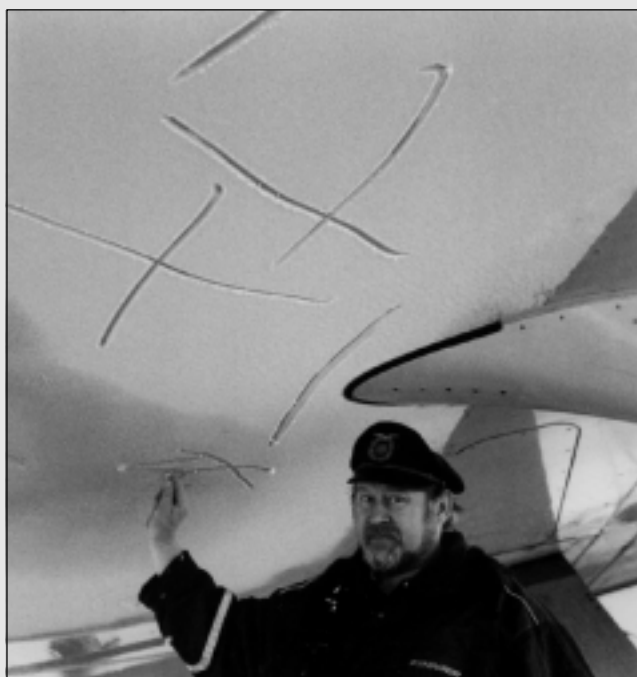
Frost formed readily under the wings in the fuel tank area.

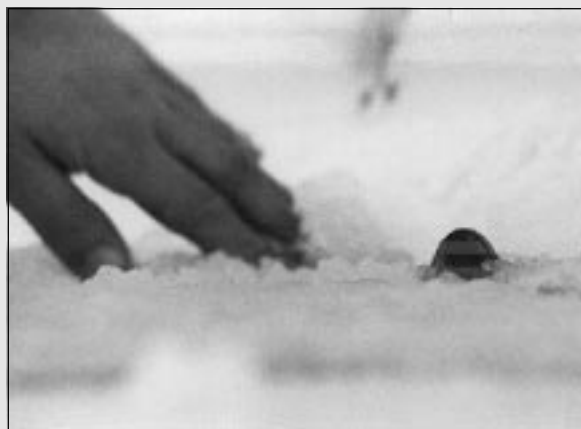
*The small brightly colored horizontal tab was buried in snow and clear ice, and provided a visual indication of contamination. It has no influence on the flight characteristics of the wing.*

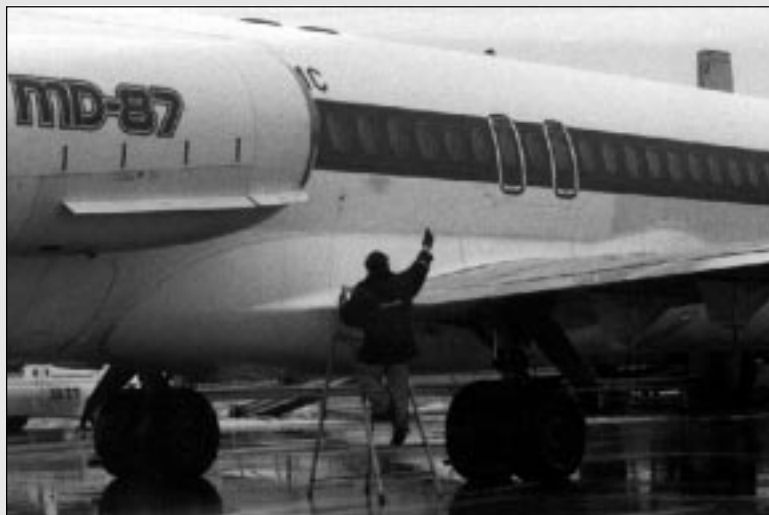
*The mechanic gave a "thumbs-up" acknowledgment to the deicing truck crew that the wing surface was clean and there was no ice on it.*

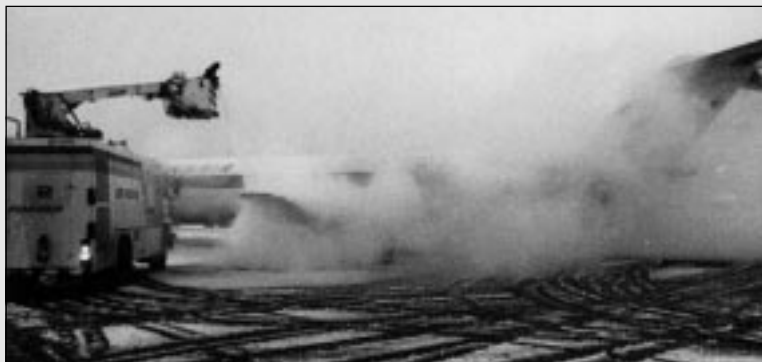
*Fog formed from the hot water used in deicing, but the Type I fluid did not seem to add any slipperiness to the snow-covered ramp.*
